High rates of **bedload** transport measured from **infilling** rate of large **strudel-scour** craters in the **Beaufort** Sea, Alaska

By: Erk Reimnitz and Edward W. **Kempema**, U. S. Geological Survey,
345 Middlefield Road, Menlo Park, California 94025

Observations on the Mode and Rate of Decay of an Artificial Ice Island in the Alaskan Beaufort Sea

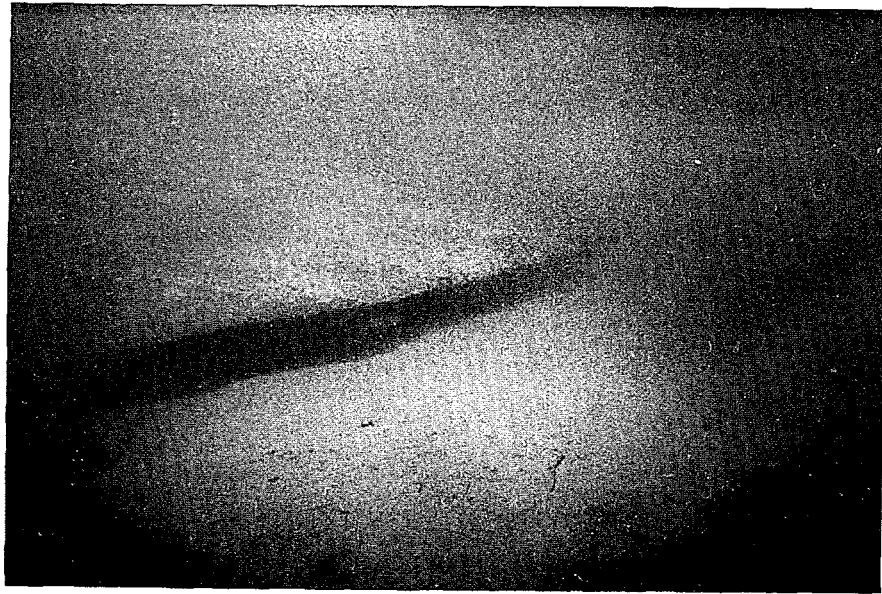
Fig. 7 — Underwater photograph of the feathered edge of ice pedestal, slightly raised above the flat sea floor. An Arctic cod is hiding below the lip of the pedestal.
